CASE STUDY

TFC Jet Pumps

TFC Jet Pump replaces ESP & greatly reduces workover cost while continually chemically treating wellbore

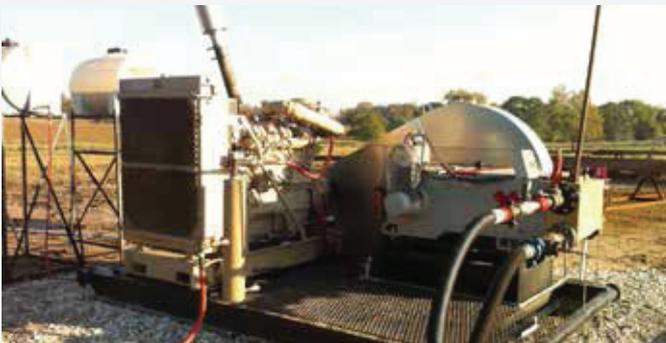
Permanent unit with Cummins natural gas engine.

After being shut in for several months, a TFC jet pump was installed in the well in August of 2011. A 200 HP triplex pump driven by a Cummins natural gas engine was selected for the surface equipment. In a matter of two days the installation process was complete and the well was producing.

After the jet pump installation completed, well production was increased to 15 bbls oil, 550 bbls water, and 27 mcfpd of gas using 150 mechanical hp. In addition, the client was able to discontinue usage of a gen set and spare the cost of bringing electricity to the location by installing the Cummins natural gas engine to utilize the well's produced gas for fuel.
